GENERAL AVIATION STRUCTURES DIRECTLY RESPONSIBLE FOR TRAUMA IN CRASH DECELERATIONS

John J. Swearingen, D.A.V.T.
FAA Civil Aeromedical Institute
P.O. Box 25082
Oklahoma City, Oklahoma 73125

January 1971

1. Report No. FAA-AM-71-3	2. Government Accession No.	3. Recipient's Catalog No.	
4. Title and Subtitle GENERAL AVIATION STRUCTURES DIRECTLY RESPONSIBLE FOR TRAUMA IN CRASH DECELERATIONS		5. Report Date January 1971

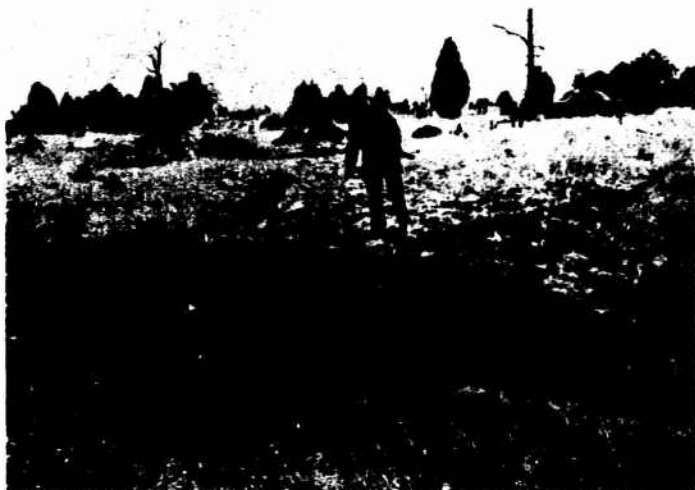
A. Crater formed by aircraft impact
38' long, 12' wide, & 4' deep.

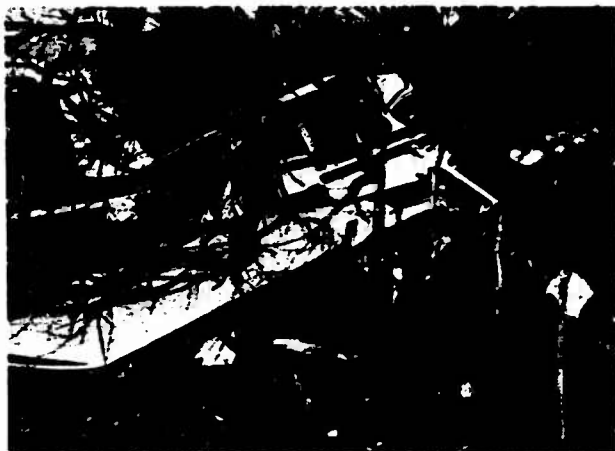
A. Overall view of aircraft impact with tree.

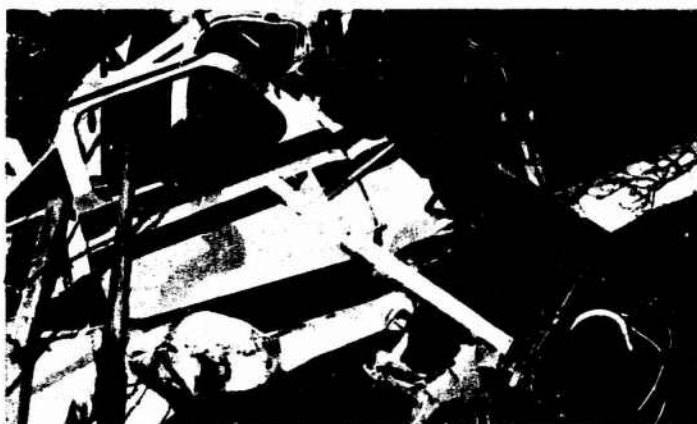
B. Close-up showing relative size of tree & depth of its penetration into the aircraft.

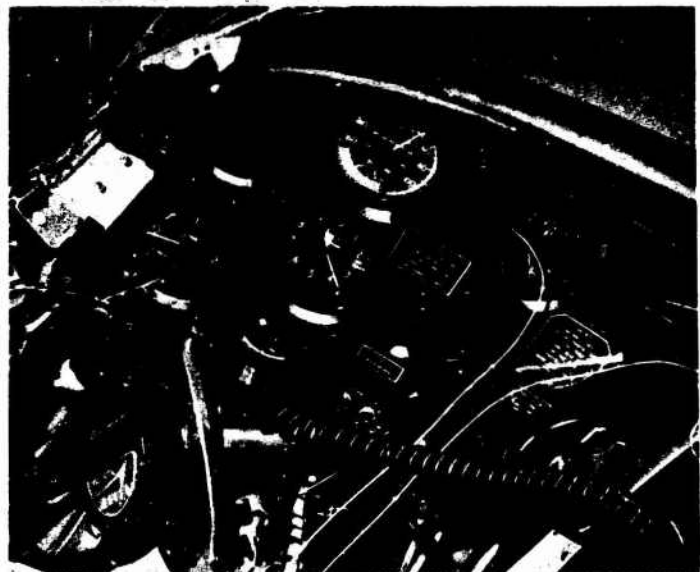
D. Left half of the instrument panel shows no signs of body impact. Note broken pieces of plastic windshield in the cockpit.

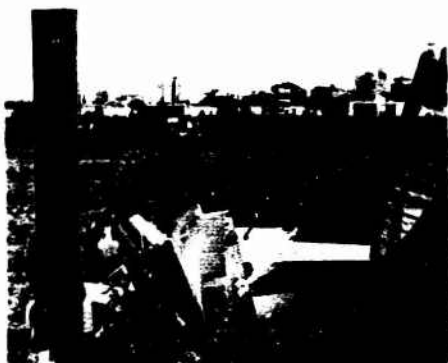
A. Aircraft after left wing impacted telephone pole.

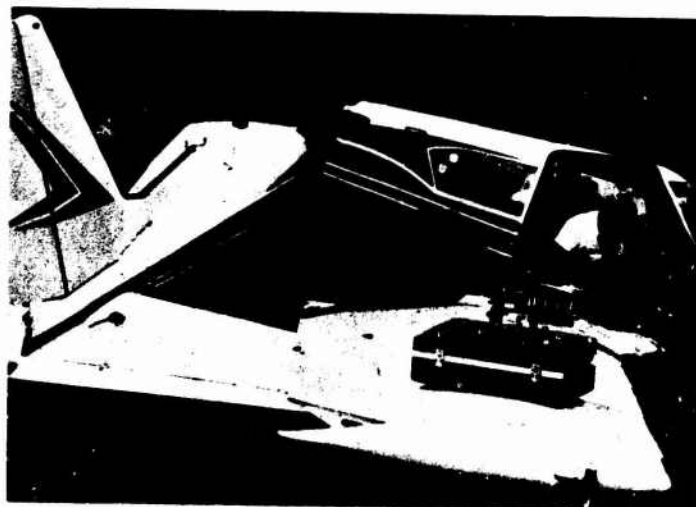
B. Final attitude of aircraft. Tail section separated at the rear of the cabin & turned 90°.

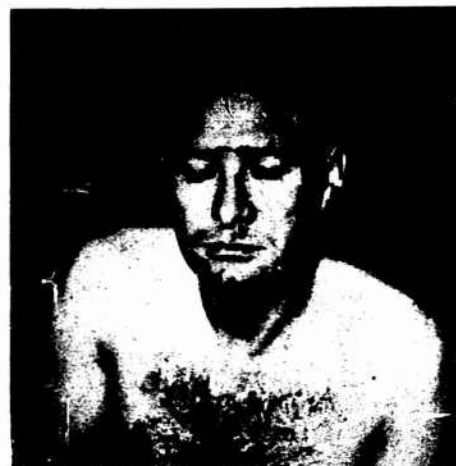
celeration of less than $\frac{1}{2}$ "g". However, since the pilot received a 5-inch laceration across the top of both eyebrows from striking the top edge of the instrument panel, we can safely state that at one point the deceleration slightly exceeded

D. Pilot with 5-inch laceration from contact with upper instrument panel.

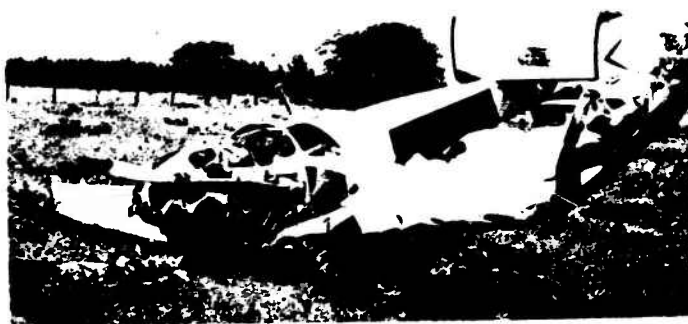
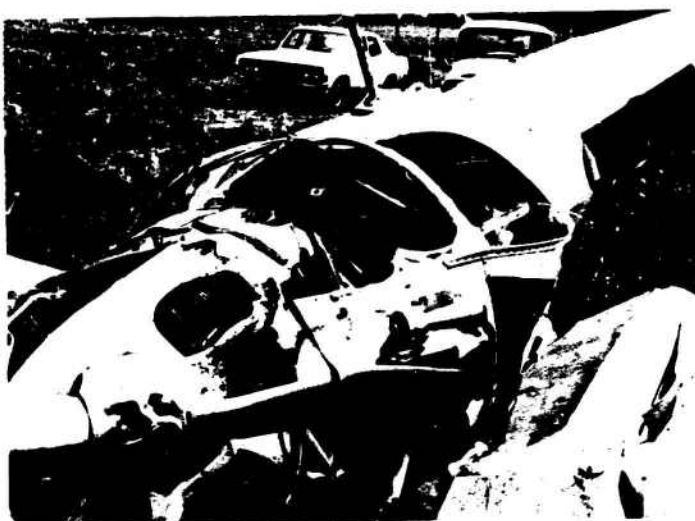
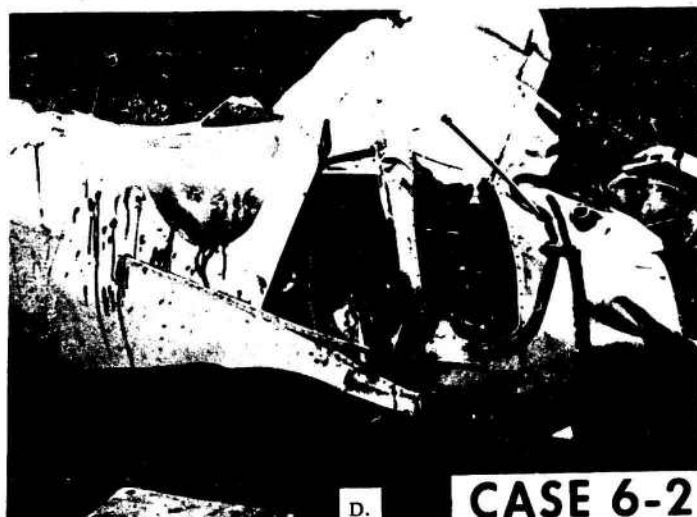
B C D

Close-up views of the exterior of the aircraft. The cabin maintained its integrity. The plastic windshield disintegrated & some outward buckling of the sides of the cockpit may be noted.

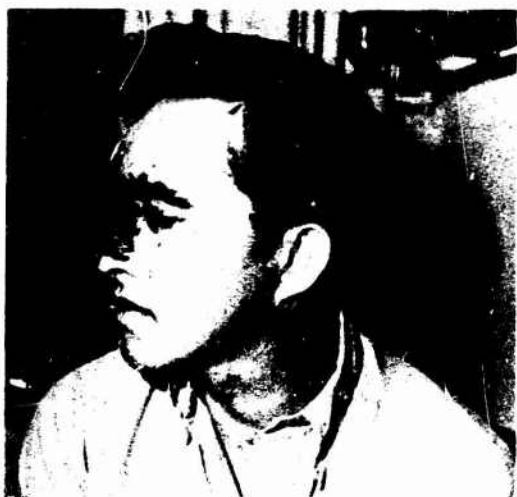
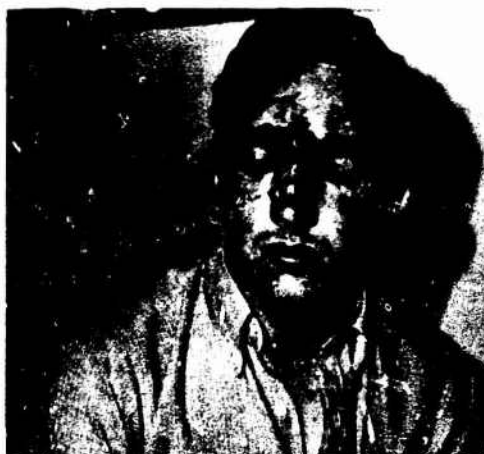
K & L Side & frontal views of facial injuries suffered by copilot when his head hit the top corner of the instrument panel (Figure F).

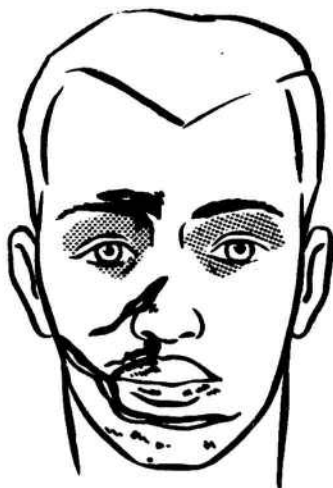
G & H Artist sketch & actual photograph of severe facial injuries inflicted.

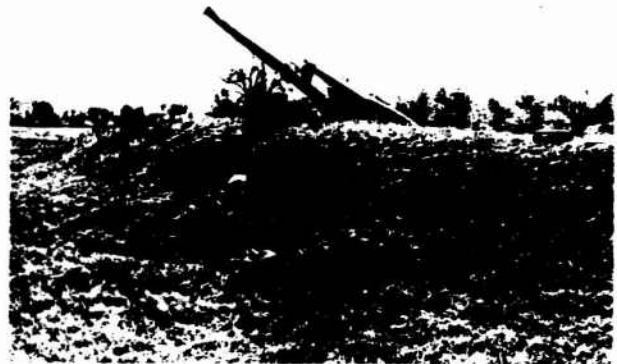
B. After traveling 420 feet in the air, aircraft impacted this dirt embankment, tore off its gear, and slid over into the pond.

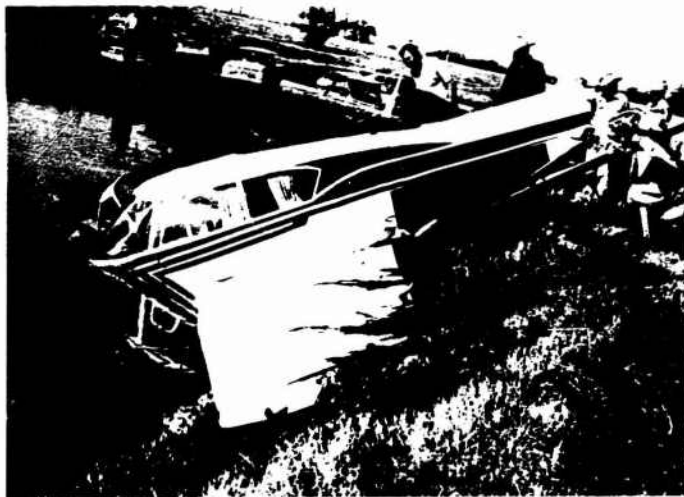
C. View of the aircraft as it was pulled out of the pond. Note cabin is entirely intact.

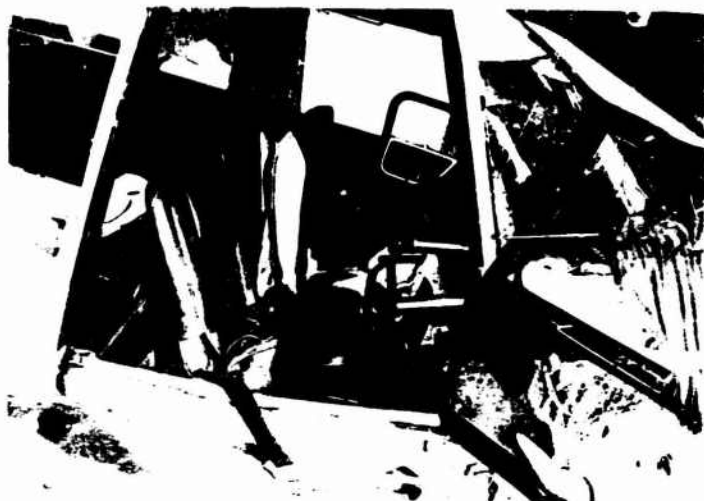
CASE 8-2

D. General appearance of cabin interior.

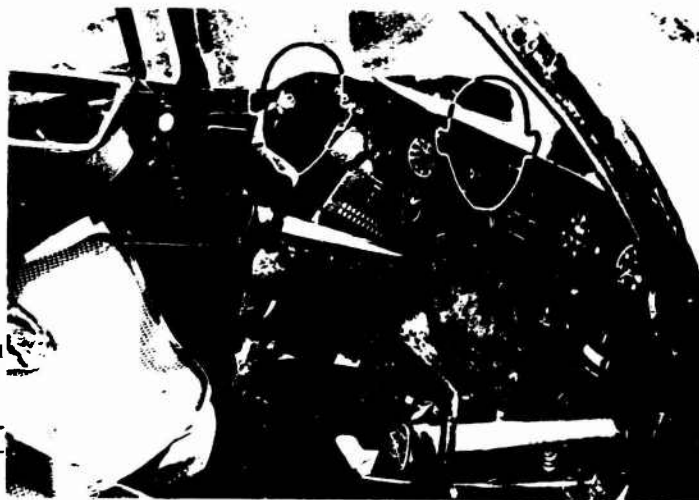
E. Head outlines indicate dented areas at top edge of the instrument panel produced by head impacts of two front seat occupants - all were knocked unconscious & drowned.

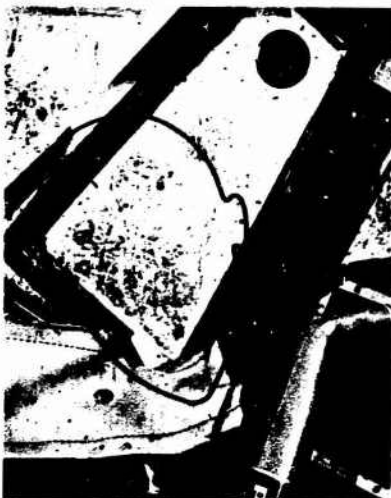
C. Area of pilot's head impact.

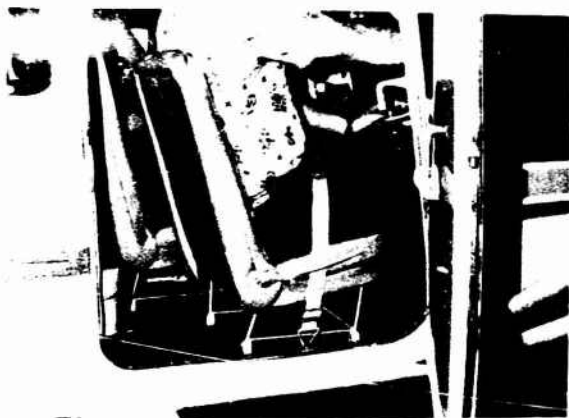
FIGURE 3. Subject wearing seat belt in 1968 Cessna 150.

the lap belts applied around the pelvic structure. The lap belt, if worn and if it does not fail, restrains only the pelvic area and allows the rest of the body to continue in motion until stopped by impacting some portion of the container. In a number of cases in this study it was noted that even the lap belt is an ineffective restraint because of faulty installation. In numerous aircraft the lap belt goes across the thighs and straight down to the floor (Figures 3 and 4) instead of across the iliac crest and then back at a 45° angle to the floor.

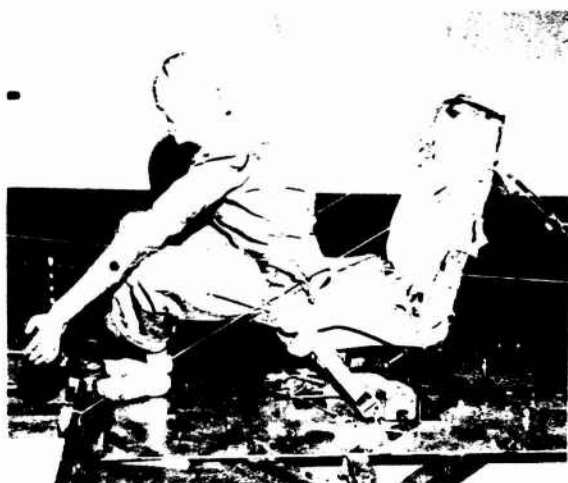
FIGURE 5. Position of dummy after crash test. Extreme forward motion is allowed by improper seat belt installation.

During deceleration the occupant is free to move forward until the belt is at nearly a 45° angle with the floor before the belt offers any restraint. By this time he is sliding off the front edge of the seat (Figure 5) and the forward motion added to belt stretch allows him to penetrate the firewall.

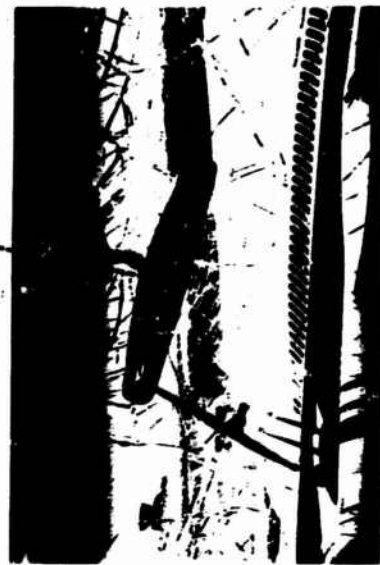
Minor lacerations on forehead
Laceration of (R) knee
Sore chest

Fractured nose (severe) and nasal spine of maxilla, cut over left eye
(L) hip and (R) hand painful but no fractures

Lacerations of both lower legs anterior

FIGURE 9. Effects on occupants in a 10.5 "g" automotive crash.

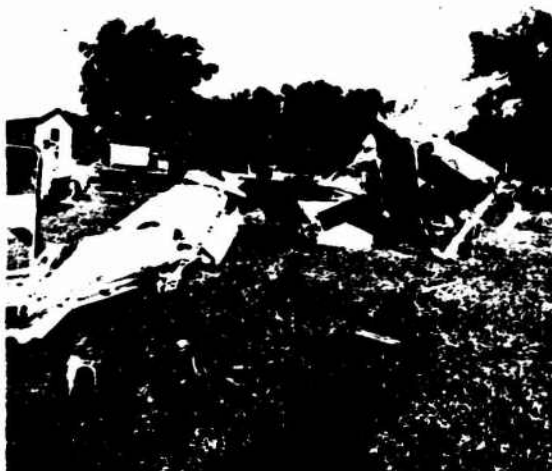
CASE 10-1

CESSNA 182 B, a 1959 model aircraft with pilot and one passenger (R. F.), was flying over a lake (approximately 18 feet from the water), flew under a telephone wire and hooked the vertical stabilizer on it, nosing over into the water. Both occupants were wearing seat belts and both belts held. No shoulder harnesses were in the aircraft. Pilot and passenger were thrown straight forward. Impact forces are not known but must, of necessity, have been very low, impacting water from only 18 feet.

A. Side shot of wreckage retrieved from the lake.

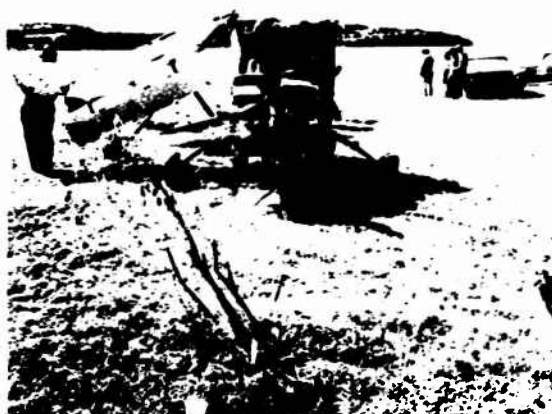
B. Front view of wreckage showing seats & seat belts still in place.

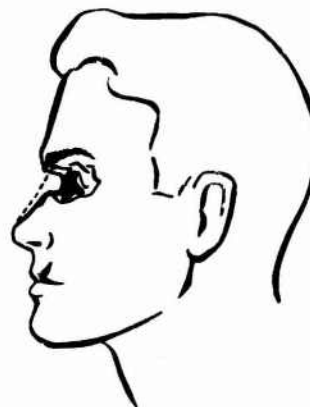
CASE 10-2

D. Fatal & only injury of pilot, inflicted by impact shown in C.

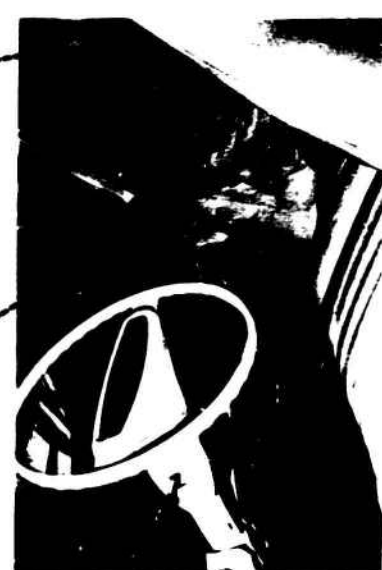
③ RIGHT FRONT
Minor head lacerations

FIGURE 18. 20 "g".

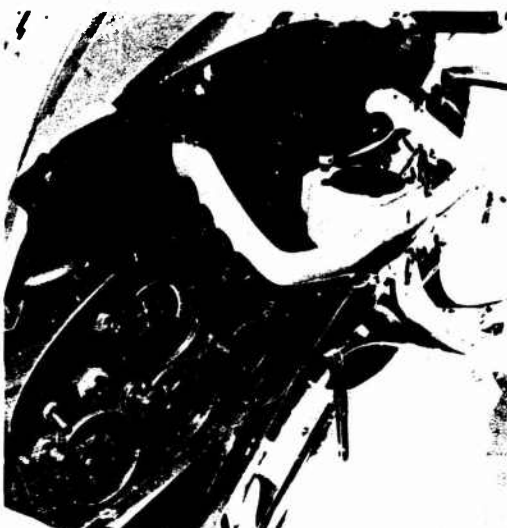
C. The left control column has been bent upward by chest impact of the pilot until the control horns rest against the light padding.

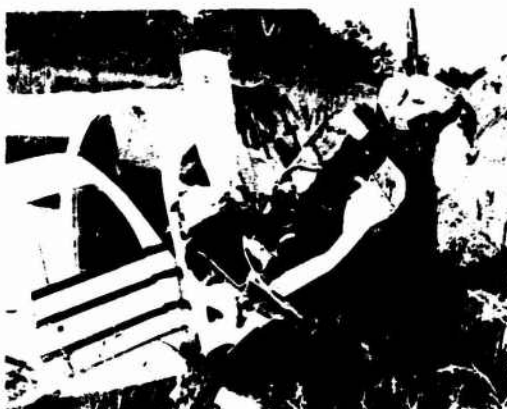
tion forces ultimately transmitted to the cabin and its occupants as long as the cabin area itself is not compromised by penetration of structure. In this case there is evidence (Case 11 A and B) that the engine was forced up during some stage of the deceleration (probably as the aircraft flipped over) until it was at right angles to the axis of the aircraft and pushed the instrument panel back toward the front seat occupants. It should be noted, however, that there is no apparent structural failure with separation at the ends of the instrument panel. It is also worthy of note that the Mooney Corporation has installed a thin layer of padding on the top of the instrument panel (Case 11 C) in this aircraft and they are to be congratulated as it probably saved this pilot from fatal head injuries. On the other hand, the significant contribution of the padding to safety was partly nullified when the heavy compass was mounted on top of the instrument panel. A severe cerebral concussion was caused by this instrument when the pilot impacted it with his head (Case 11 D). In the same figure it is obvious that the pilot received his severe scalp lacerations on the broken plexiglass windshield and a fractured mandible with the loss of several teeth on the right horn of the control wheel which his body had bent up into the facial impact area. These plexiglass windshields have caused numerous severe lacerations, some fatal, as will be seen in other cases presented later in this report. Late-model automobiles are equipped with thin, strong, laminated glass windshields which have greatly reduced the head penetration and severe laceration problems. The control wheel in this aircraft is poorly designed from the standpoint of crash injury prevention. The horns frequently break off and sometimes penetrate the chest. Mounting a heavy protruding instrument with a reset knob protruding even further in the center of the control wheel significantly increases the chance of serious to fatal chest injuries. Beech redesigned their control wheel to fit the chest contour and eliminated the horns and protrusions 20 years ago. Cessna later developed a similar, well-designed control wheel (refer to Case 7). It should be noted, however, that both of these companies have gone back to the horned control wheel in some of their latest aircraft. The heavy radio with protruding knobs in the center of the instrument panel and the row of extended heavy aircraft controls (power, mixture, pro-

B. Motor forced upward, pushing instrument panel inward.

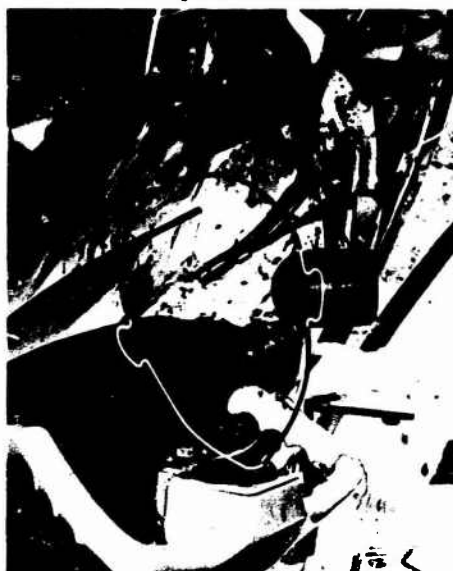
D. Pilot's head struck the broken plexiglass windshield, heavy compass, & right horn of the control wheel.

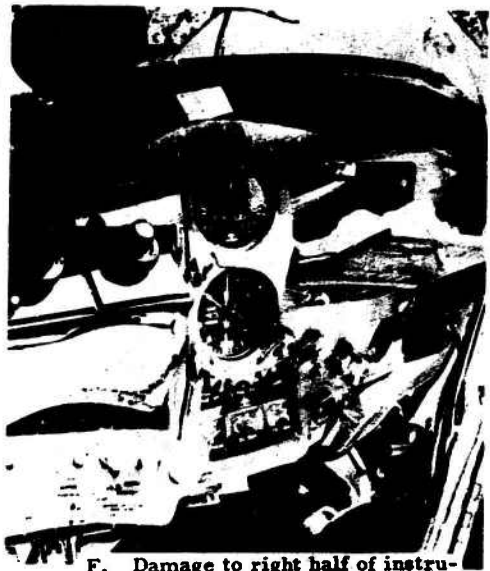
F. Damage to right half of instru-
ment panel from unrestrained
stretcher.

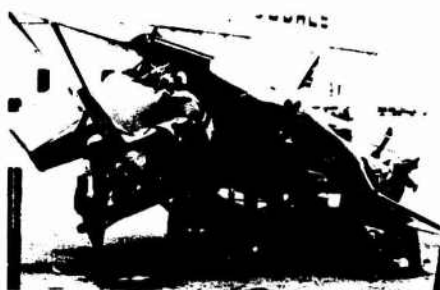
In Case Number 12 there has been a complete separation of the cabin structure at both ends of the instrument panel (Case 12 B and C) as a result of the impact. Since this 1955 Piper Tri-pacer PA 22-150 has doors on both sides, the only structure preventing the engine and instrument panel from being pushed back into the faces of the front seat occupants is the "A" post on each side of the windshield. The inboard half of each seat belt was attached to the seat while the outboard half was attached to the fuselage. Attaching lap belts to seats loads the seat tie-down attachments unnecessarily, often causing them to fail and the package contents are no longer even partially restrained. Seat attachments in this case did fail (Case 12 I, J, K and L), allowing the two front seat occupants to smash their faces into the formidable structure of the upper instrument panel and their knees and legs into the prong-studded lower panel (Case 12 D). Facial injuries were more severe in this case than in Case 11, partially because there was no padding on the instrument panel and partially because the crash impact force was slightly greater as attested to by the significant increase in lower leg injuries. The bare survival of these two oc-

B. View from left side of aircraft showing that only the structure between the rear door & motor protected the pilot from being crushed.

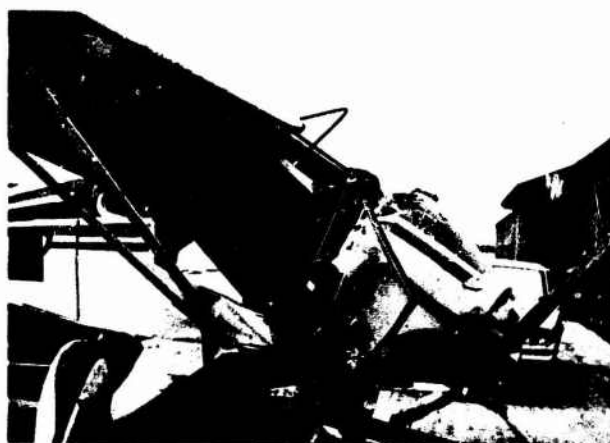
C. Close-up of right side of aircraft shows complete failure of right "A" post. (Only structure resisting backward displacement of motor & instrument panel on that side).

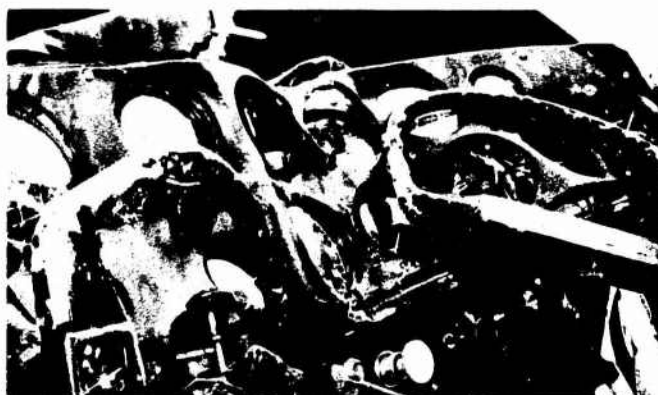
G. Close-up of copilot's head imprint.

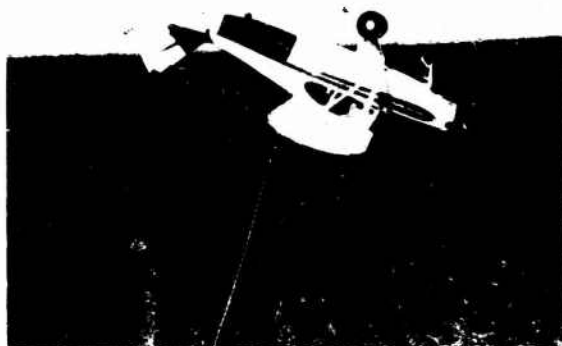
A & B Two views of aircraft that simply flipped over onto its back without damage.

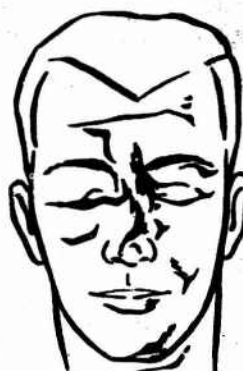
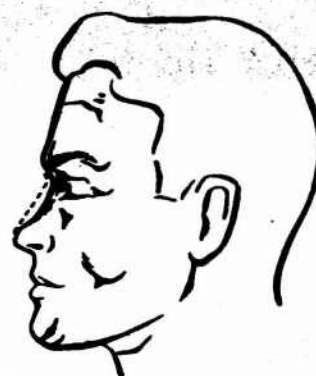
D. Photograph & artist sketches of head injuries of front seat passenger.

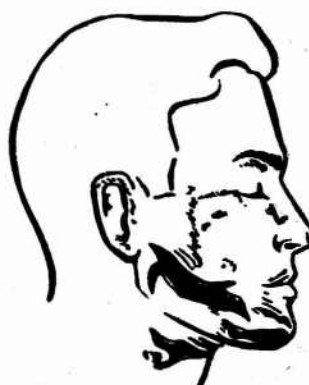
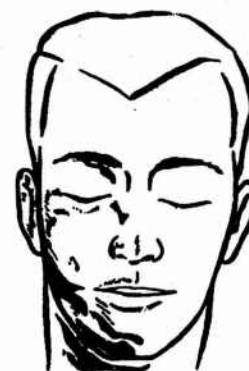
E. Pilot (rear seat) head injuries. Note lacerations from broken windshield.

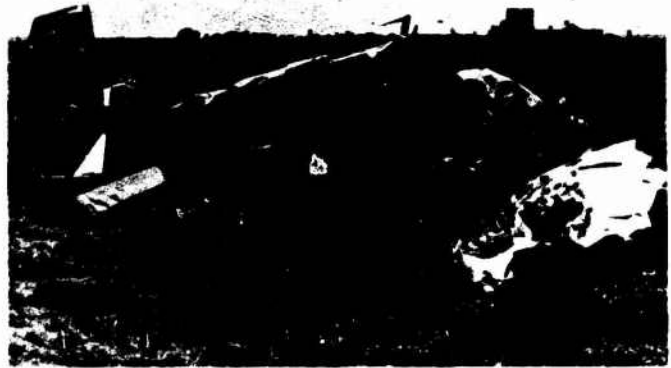
B. Right view shows cabin structure failed & opened up.

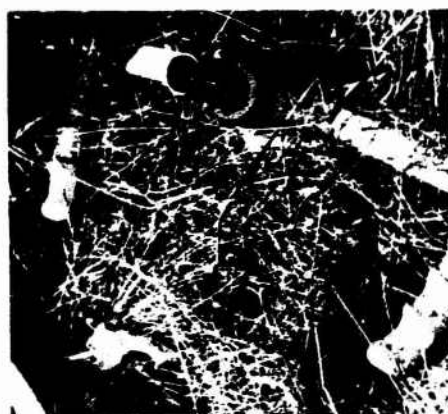
M. Tubular control column broken off.

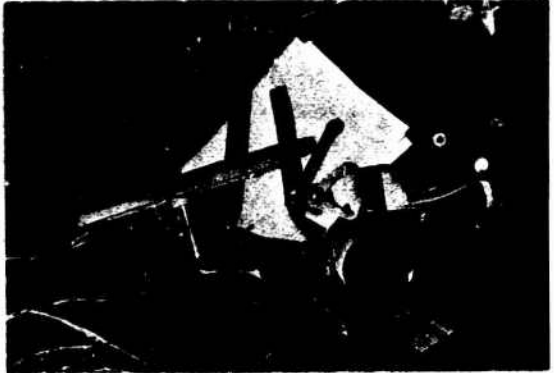
E. Pilot received massive puncture of all major body viscera when control column bent to form a spear after seat belt attachment failed.

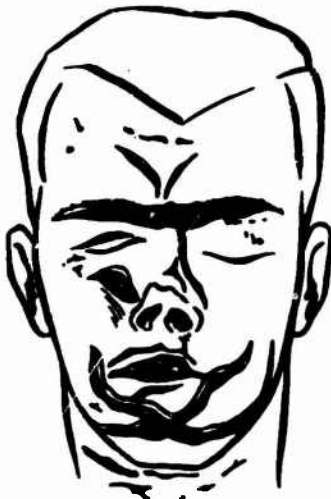
C. Artist sketch of severe lacerations & facial crushing resulting from impact with the instrument panel.

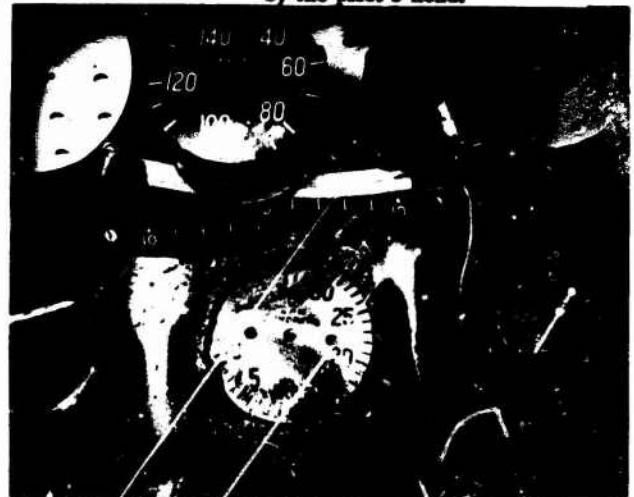
D. Close-up of heavy instruments struck by pilot's head.

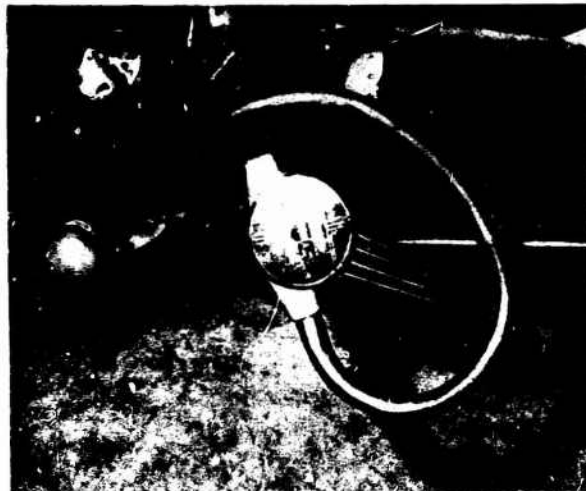
I. Copilot's control wheel.

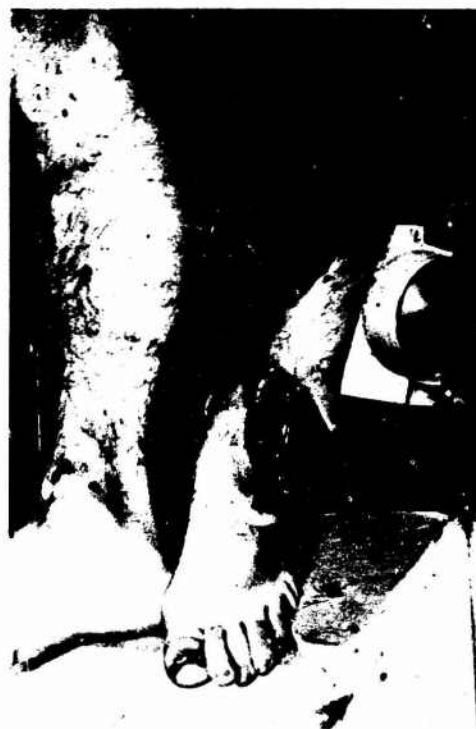
J. Lower leg injuries.

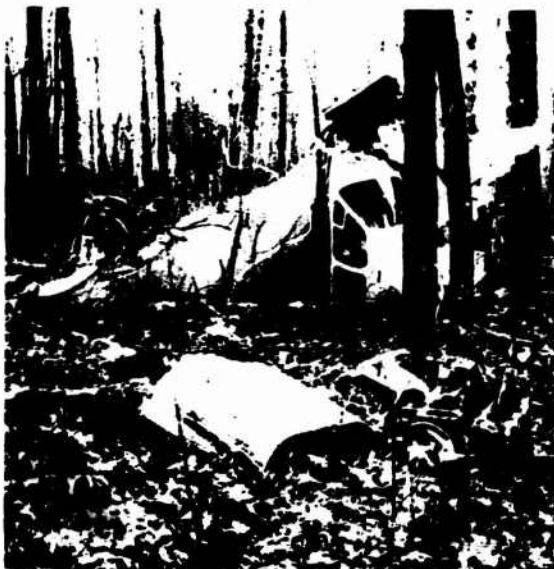
A. Wreckage of Beech Bonanza. Note that the tail, wings, & motor are torn away, but the cabin is intact.

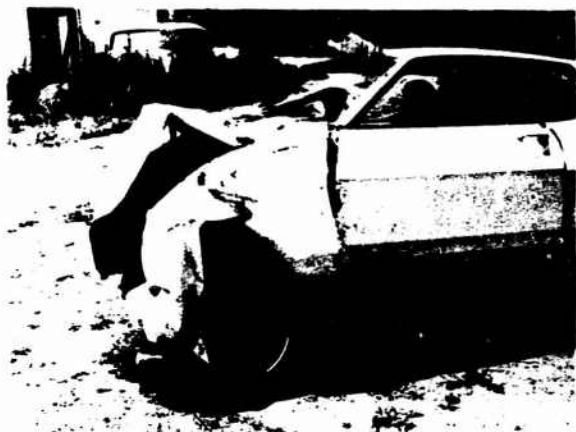
FIGURE 30. Side view of vehicle showing crushing of front end during deceleration.

ment measured 8 to 12 inches. Hence, it can be calculated that the average deceleration of the car was in excess of 50 "g". Even with these very severe impact forces, the shipping container maintained its integrity and the heavy motor was pushed back under the floor board and not into the cabin. While it is doubtful if light aircraft cabins can be designed to withstand "g" forces of this magnitude, their interior certainly could be modified to incorporate some of

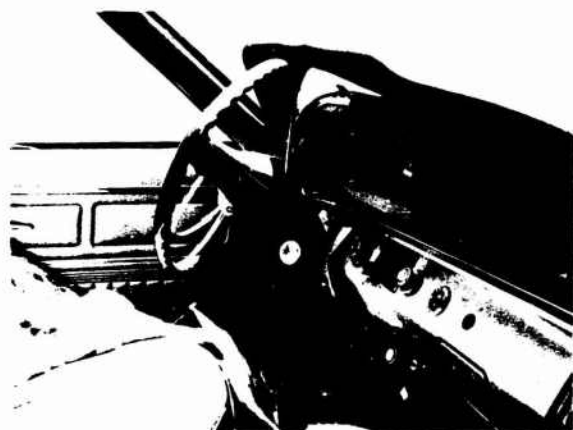
FIGURE 31. Right knee impact area.

the succesful design principles for crash survival illustrated in this accident. Although both shoulder harness and seat belt restraint were available in this automobile, the driver was not utilizing either. As a result, his body slid forward in the seated position until his knees embedded themselves in the lower dash (Figures 31 and 32), a smooth, rounded, ductile metal without knobs or rigid edges. His chest contacted the large diameter steering wheel contoured to fit the body and distribute the load over a large chest area (Figure 33). The chest impact was of sufficient force to crush the collapsible control column mechanism to its maximum distance (8") (Figure 34). At the same time his head was impacting the padded sunvisor and pushed it through the windshield (Figure 35). The only injuries suffered by the operator of this automobile were a laceration of the face and a small puncture wound on the upper left arm, both resulting from contact with the broken windshield.

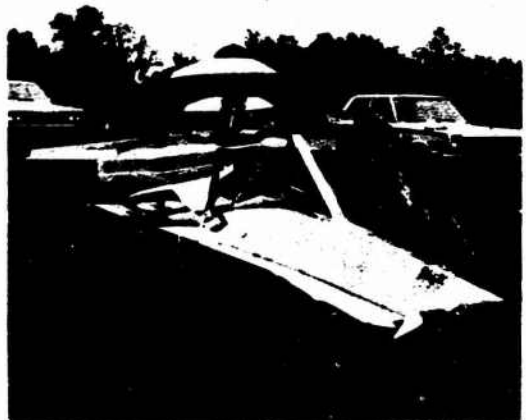
B. Forward motion of the aircraft was stopped when motor plowed under a large flat rock.

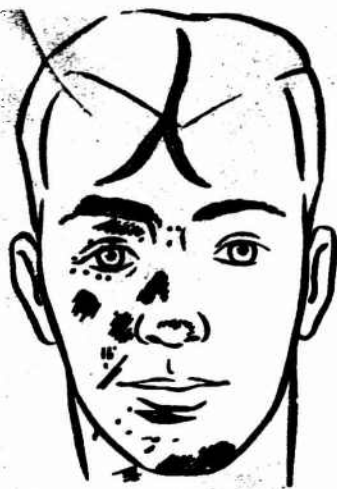
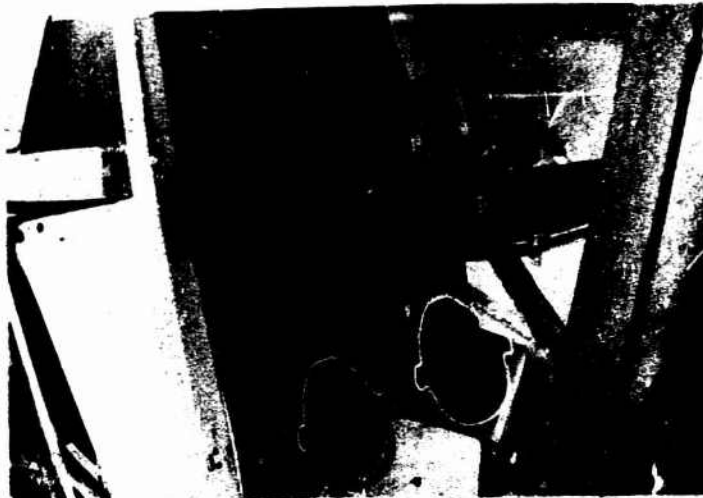
F. Head outlines of head positions in inverted aircraft.

E & G Artist sketches of lacerations & abrasions of 2 occupants heads from dragging along the ground & contact with torn metal from top of cabin.

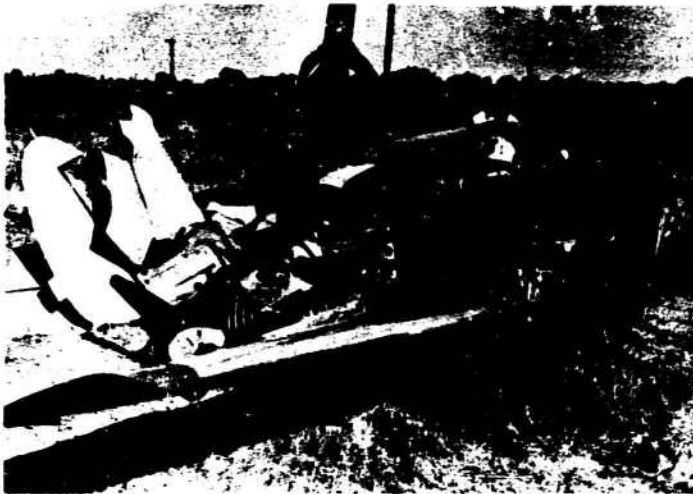
A. Telephone pole is completely buried in fuselage after side impact by aircraft.

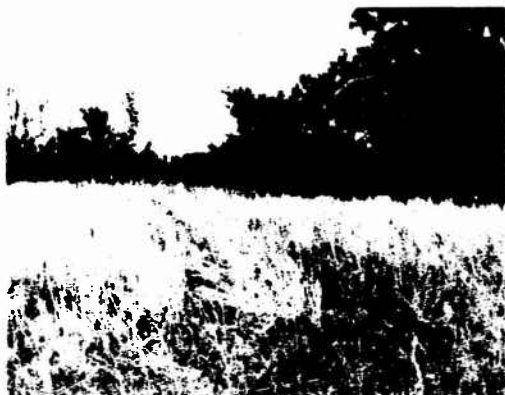
A. Distant view of crash site. Tracks in wheat field were made by rescue personnel as aircraft did not touch the ground before striking the tree.

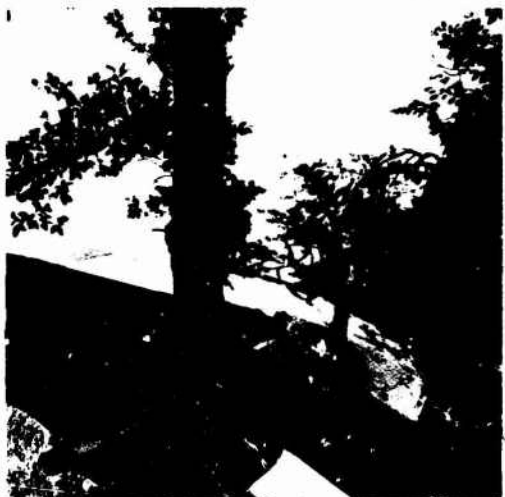
C. Right side of aircraft. Note bark missing from tree & snagged control cable about 5 feet above the ground.

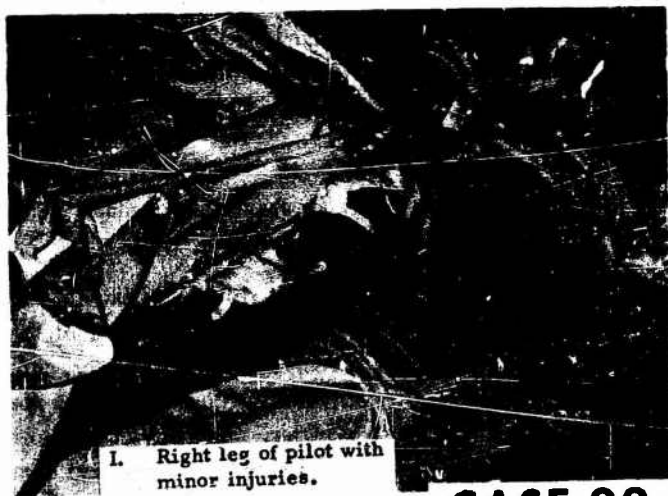
I. Right leg of pilot with minor injuries.

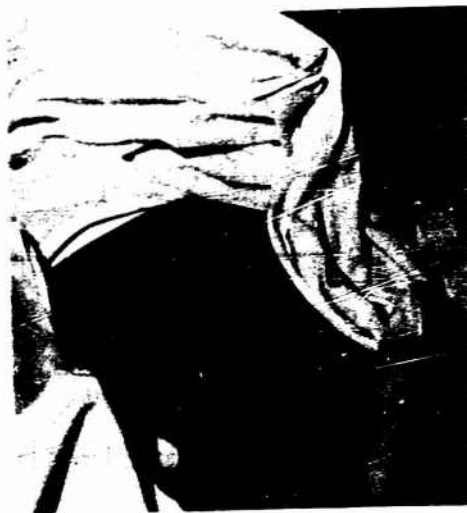
F. Seat belt abrasion on copilot.

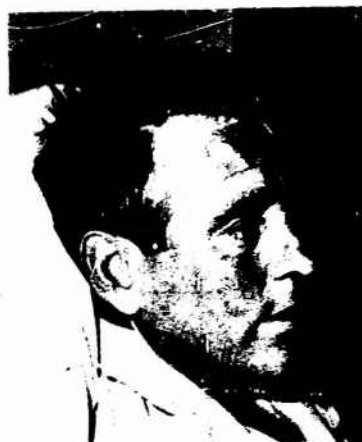
H. Pilot with minor laceration of forehead.

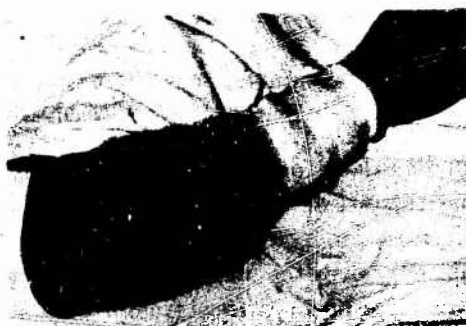
J. Minor lacerations of pilot's right elbow.

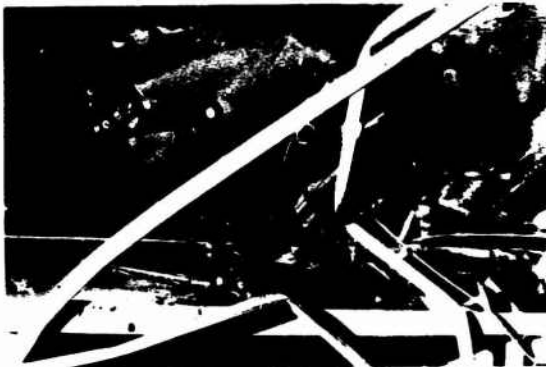
D. Seat attachments held since belts & harness were attached to fuselage.

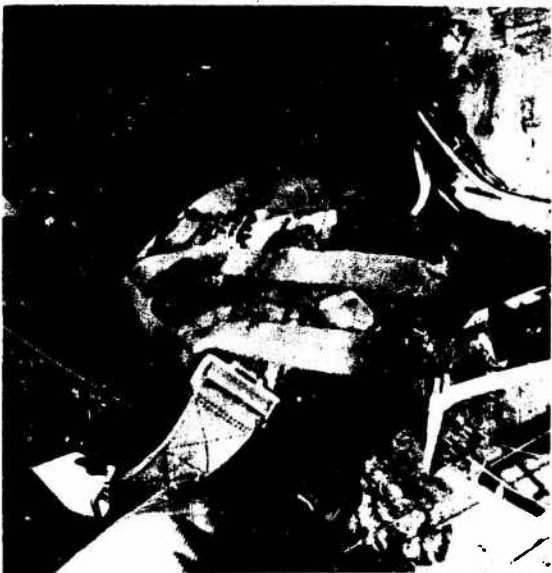
E. Shoulder harness & 3" seat belt broke.

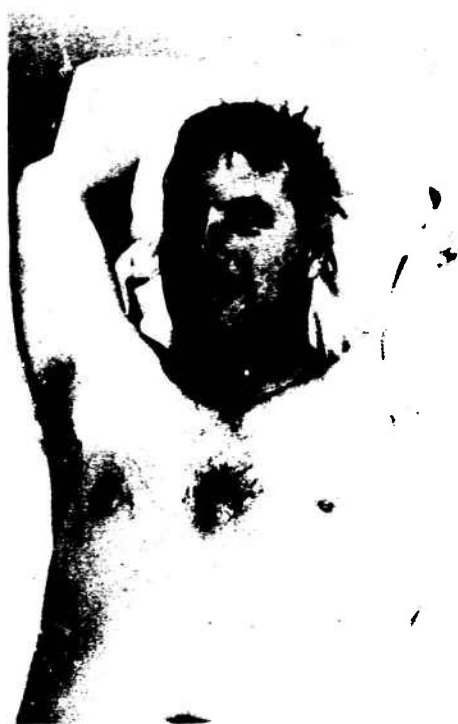
G. Pilot with minor bruises & facial lacerations 4 days after crash.

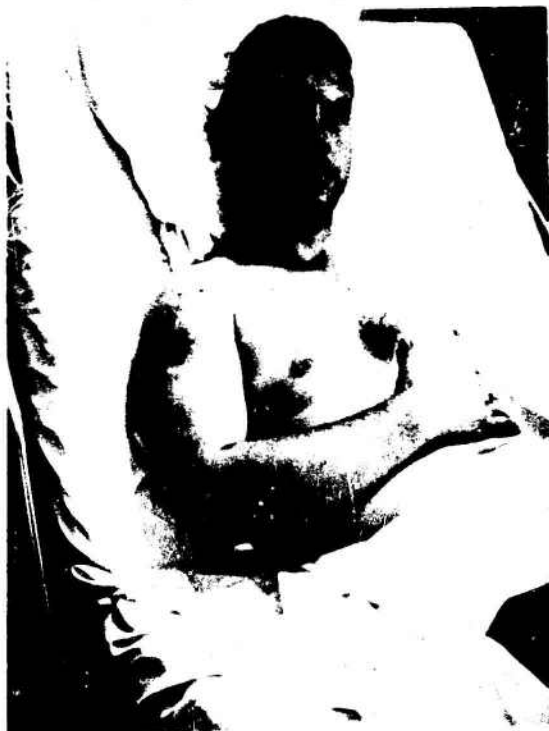
H. Bruise on right shoulder from contact with microphone.

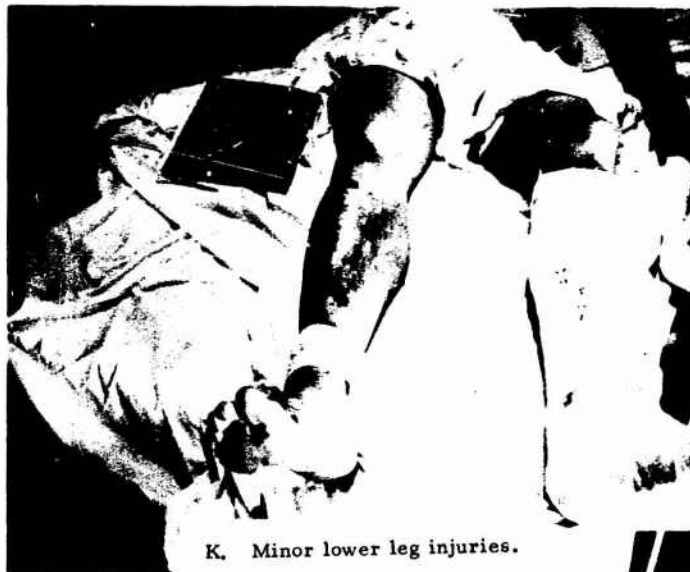
K. Minor lower leg injuries.

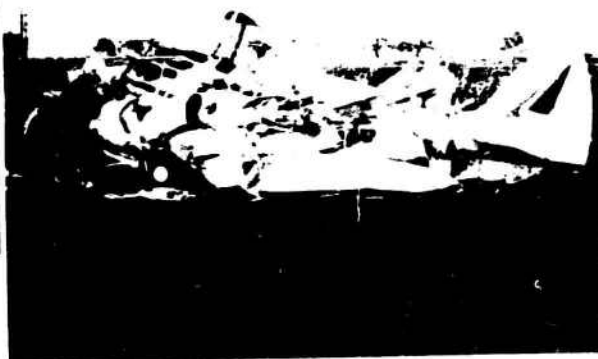
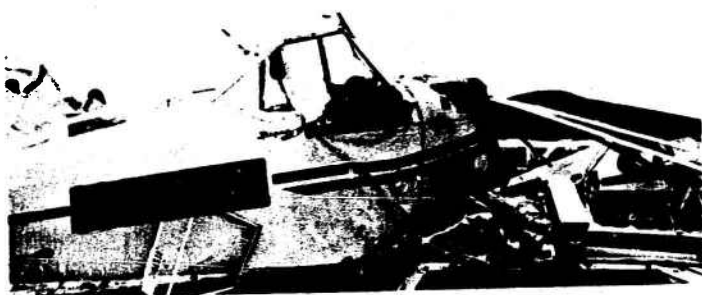
CASE 24-1

A, B & C Various views of aircraft showing how tubular construction around the cabin prevents its collapse on the pilot even in severe crash impacts.

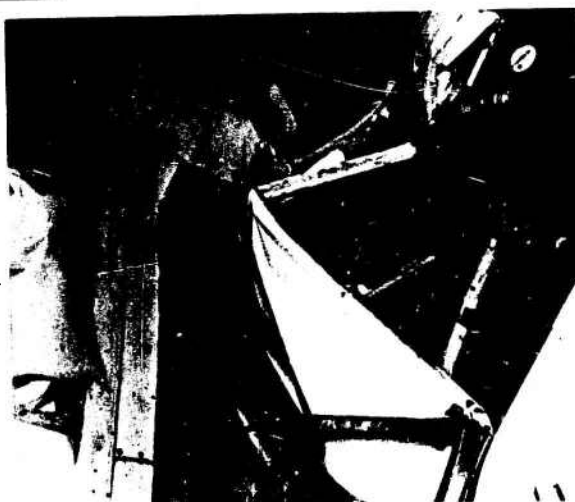
D. Sides of Pawnee cockpit are designed to buckle outward away from the pilot.

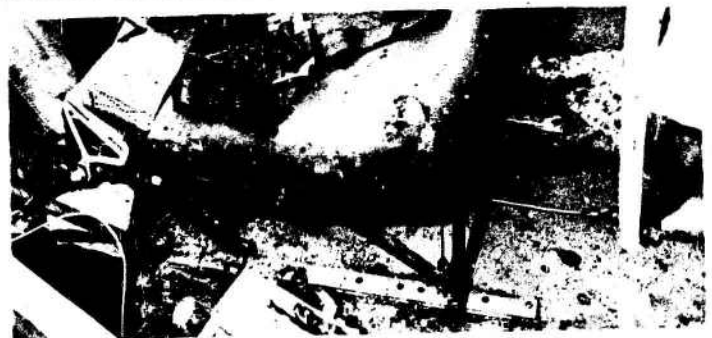
G. Shoulder harness failed in webbing but seat & seat belt held.

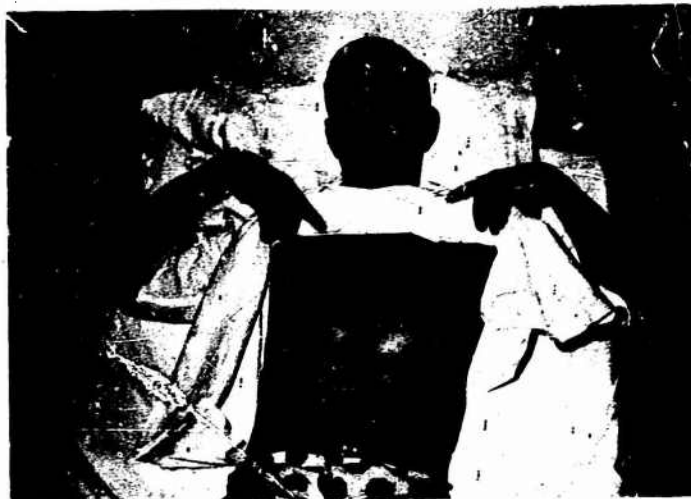
I. No chest injuries.

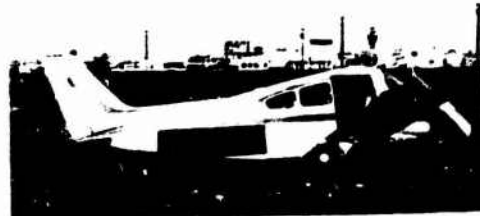
B & C Short 6-foot gouge mark under the aircraft, upward bending of the landing gear, & downward bending of motor all indicate that the aircraft crashed nearly flat with heavy vertical loads.

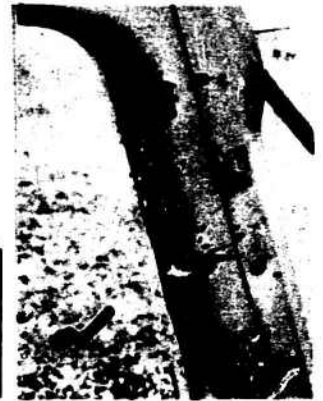
F & G Copilot's head struck compass & top center edge of instrument panel.

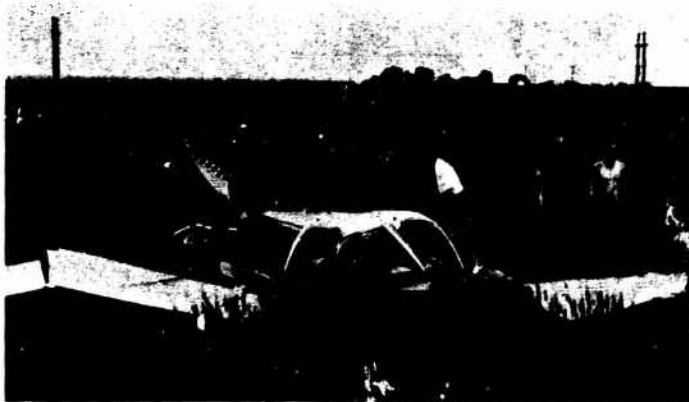
CASE 27-1

A. Aircraft crashed flat in a tall wheat field. Note wheat all around aircraft is undisturbed.

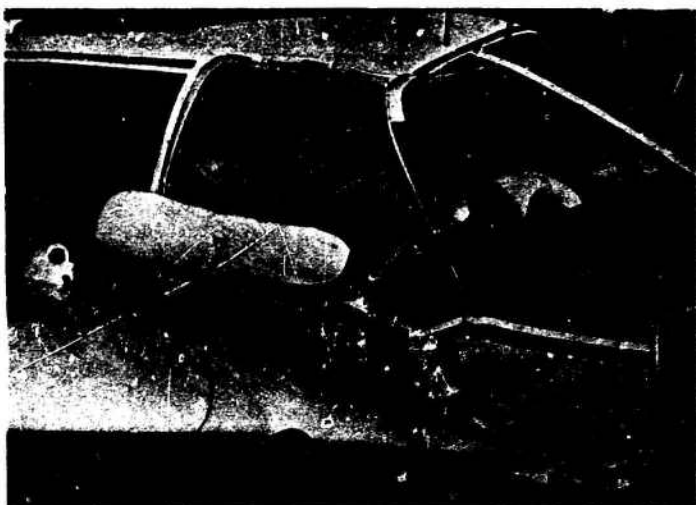
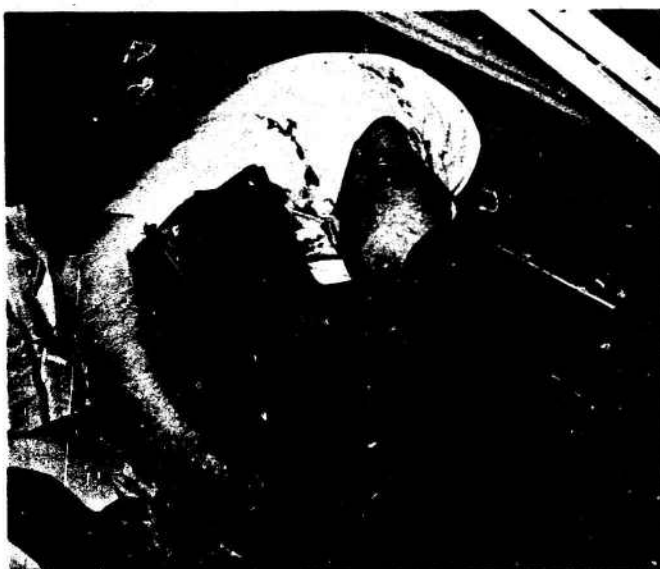
CASE 27-2

C & D Front seat occupants appear to be uninjured & asleep.

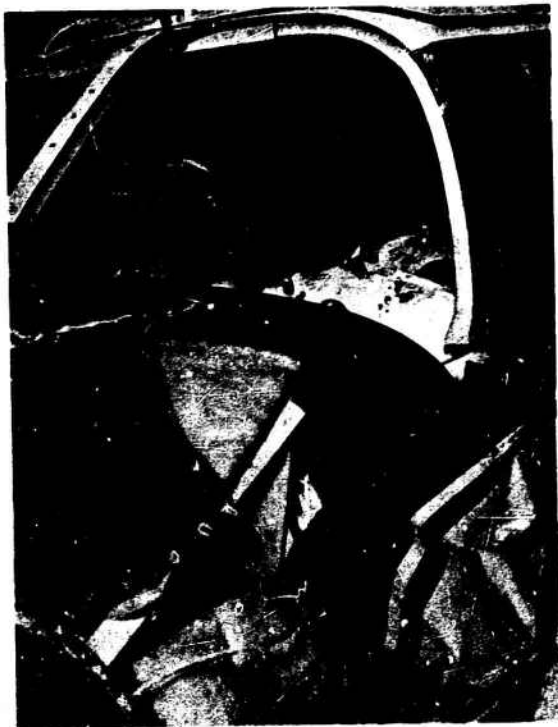
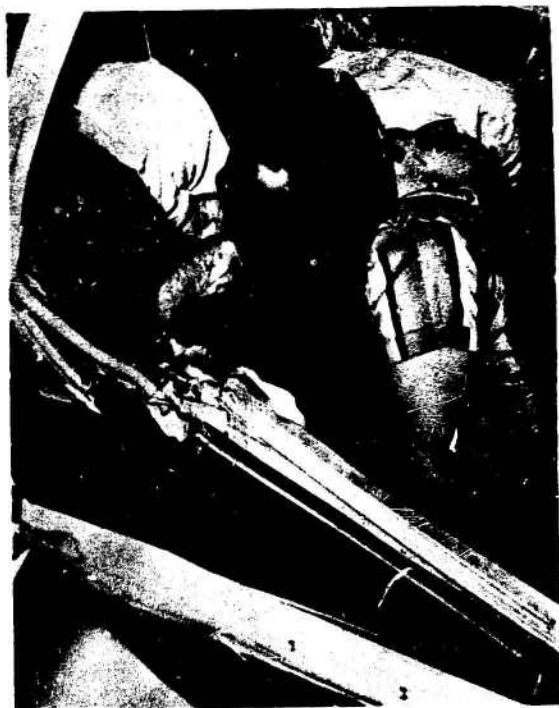
CASE 27-3

E & F Views of right front & center seat occupants.
